**Flood Control Project Maintenance
Levee Inspections**

Maintenance Issue Types Only, Levee Inspection Report By Mile - Fall 2014

Sutter Maintenance Yard Maintenance Area 0007

Waterway	Bank	Unit Miles	Inspection Start/End	Inspector
Unit No. 01 Feather River	Right	11.90	11/19/2014 11/19/2014	Matthew Hoffman

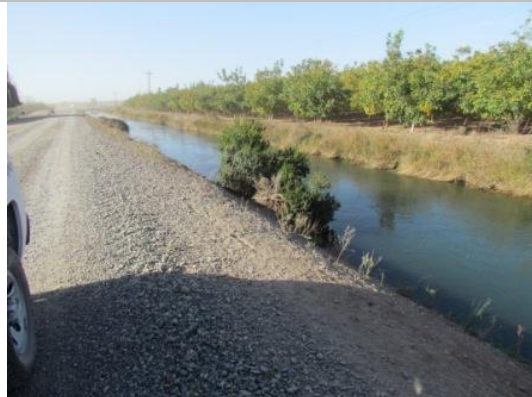
Photo 1 of 1 : FA_2014_MA0007_200_216_20141110_00012.jpg

LM Start	0.42	Rating **	M	Issue No.	216
LM End	0.42	Issue Type +	Ma	Location *	LS
Category	Earthen Levee			GPS Latitude/Longitude	
				Start	End
Item	Trim / Thin Trees			39.316451 °	39.316451 °
				-121.633837 °	-121.633837 °
DWR ID	DWR_MA0007_01_f_2013_216				
Action/Comments					
Thin trees to allow visibility of the ground and room to flood fight. Inspector Comments: Remove tree between levee crown and ditch on landward side.

This photo was taken from the levee crown facing south looking down the landward slope at a tree growing near the toe. Fall 2013.

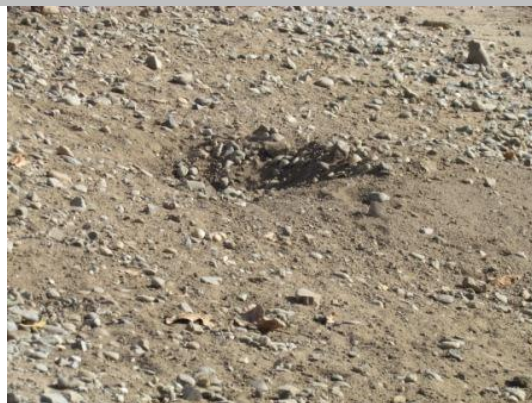
Photo 1 of 2 : FA_2014_MA0007_200_217_20141110_00013.jpg

LM Start	0.46	Rating **	M	Issue No.	217
LM End	0.46	Issue Type +	Ma	Location *	WS
Category	Earthen Levee			GPS Latitude/Longitude	
				Start	End
Item	Animal Control			39.317050 °	39.317050 °
				-121.633331 °	-121.633331 °
DWR ID	DWR_MA0007_01_f_2013_217				
Action/Comments					
No rodents visible, but rodent burrows visible; need to backfill and compact or grout burrows. Inspector Comments: Rodents holes were observed but no rodents visable at time of inspection.

Up close photo of said rodent holes. Fall 2013.

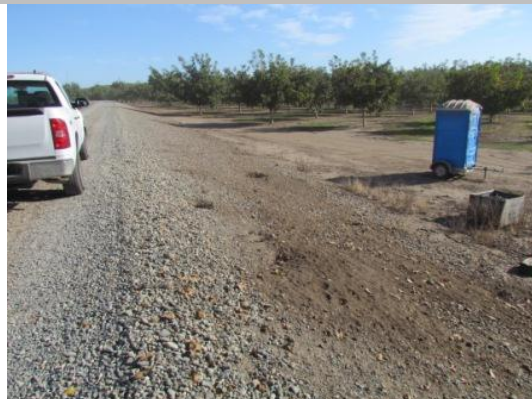
Photo 2 of 2 : FA_2014_MA0007_200_217_20141110_00014.jpg

This photo was taken from the crown of the levee facing north looking down the slope at rodent holes. Fall 2013.
